# Section 4

## Storm Water Management System

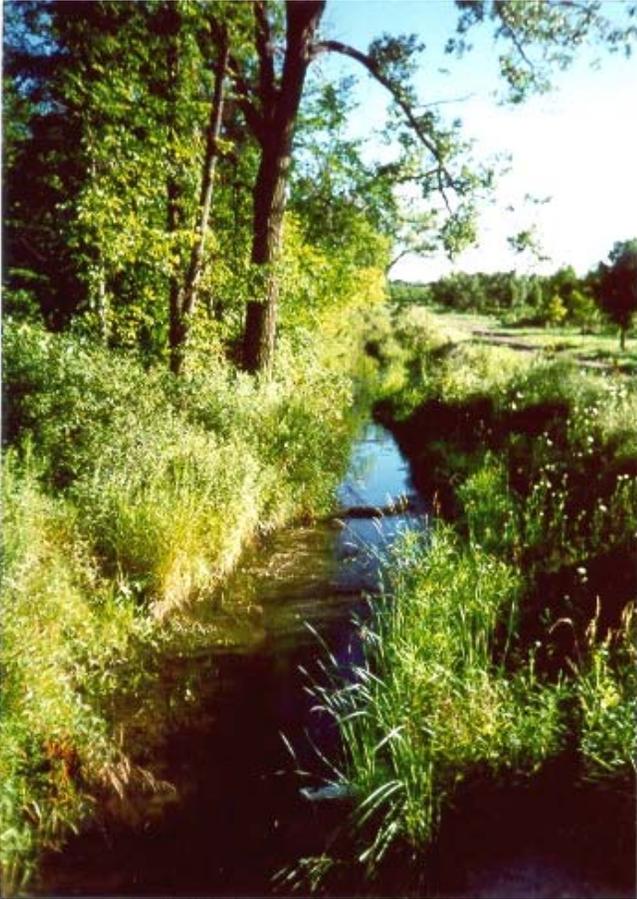
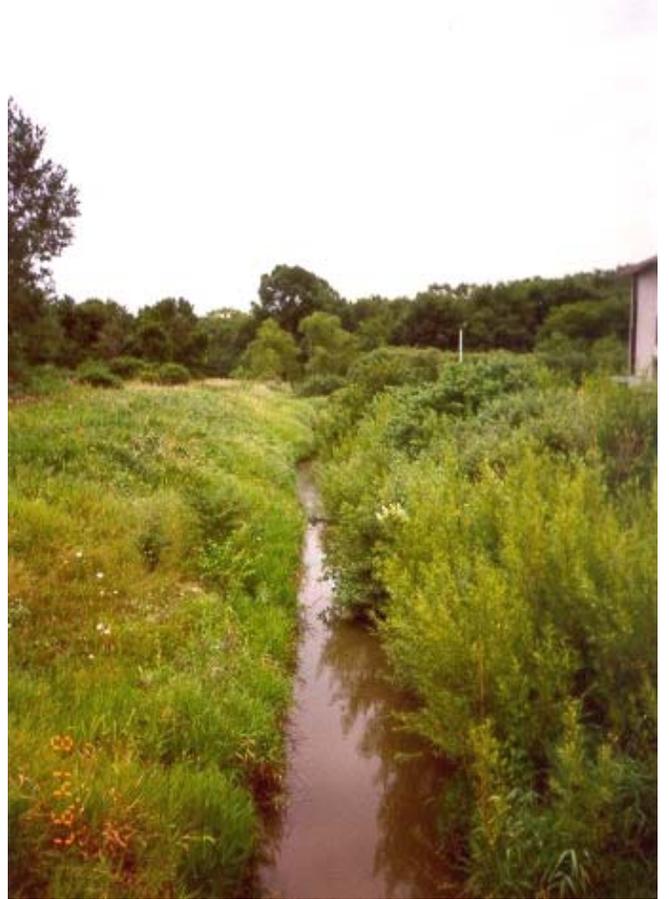
Figure 4-3: Examples of stream reaches rated good.

Figures 4-3, 4-4, and 4-5 show examples of stream reaches inventoried and the classification rating.

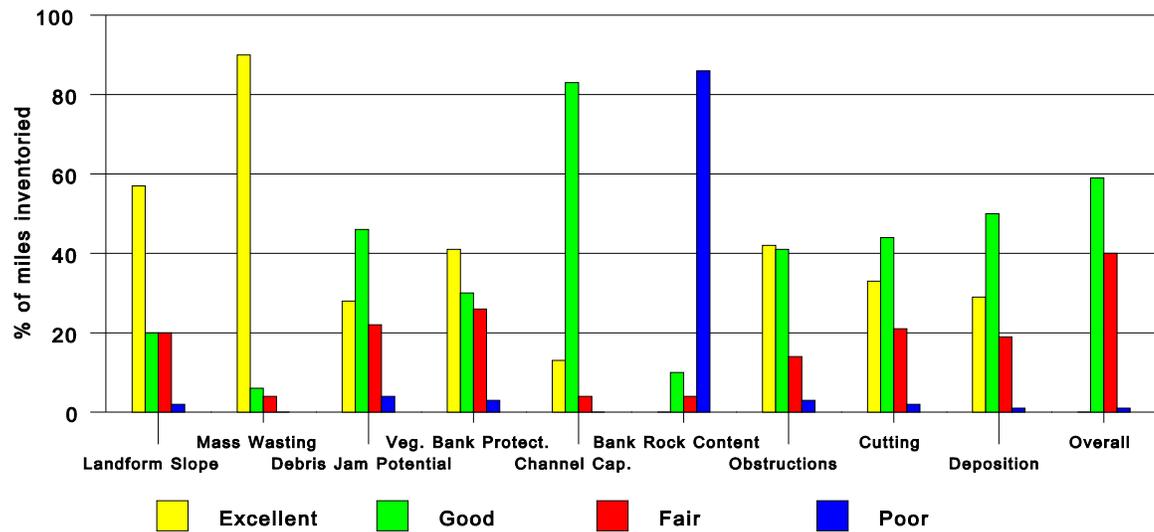
Figure 4-6: Summary of the Streambank Indicator Classification

- Of the streambanks inventoried, the overall reach condition of 19.8 miles, or 59 percent, is classified good; 13.4 miles, or 40 percent, is classified fair, and 0.2 miles, or 1 percent, is classified poor.

- Bank rock content is classified poor for 88 percent of the stream. This indicates that 20 miles of streambank have less than 30 percent rocks in the bank and is a reflection of the overall geology of the area.

- Vegetative bank protection, debris jam potential, and landform slope are the most common indicators, other than bank rock content, to be rated fair or poor.

- 9.5 miles, or 29 percent, of the streambanks have less than 70 percent plant density.
- 8.7 miles, or 26 percent, of the streambanks have the quantity and size materials present for the potential to create a flow deflection or debris jam.

- 7.2 miles, or 22 percent, of the streambanks have a slope greater steeper than 40 percent.

- Evidence of mass wasting was generally not observed in the streambank inventoried.
- The Upper Root River, Poplar Creek, Calhoun Creek, and Underwood Creek subwatersheds have the greatest percentage of streambanks showing significant signs of erosion, streambanks with an overall classification of fair or poor.
- The Deer Creek, Tess Corners Creek, and Mill Creek subwatersheds have the greatest percentage of streambanks in good overall condition. Poplar Creek and Deer Creek subwatersheds have the most miles of streambank in good overall condition.

A summary of the streambank classifications is presented in Table 4-2 and shown on Figure 4-6. Inventory results for each reach of stream inventoried are presented in Appendix B. The overall stream classification rating based on the inventory is also shown on Plate 1 in Appendix A.

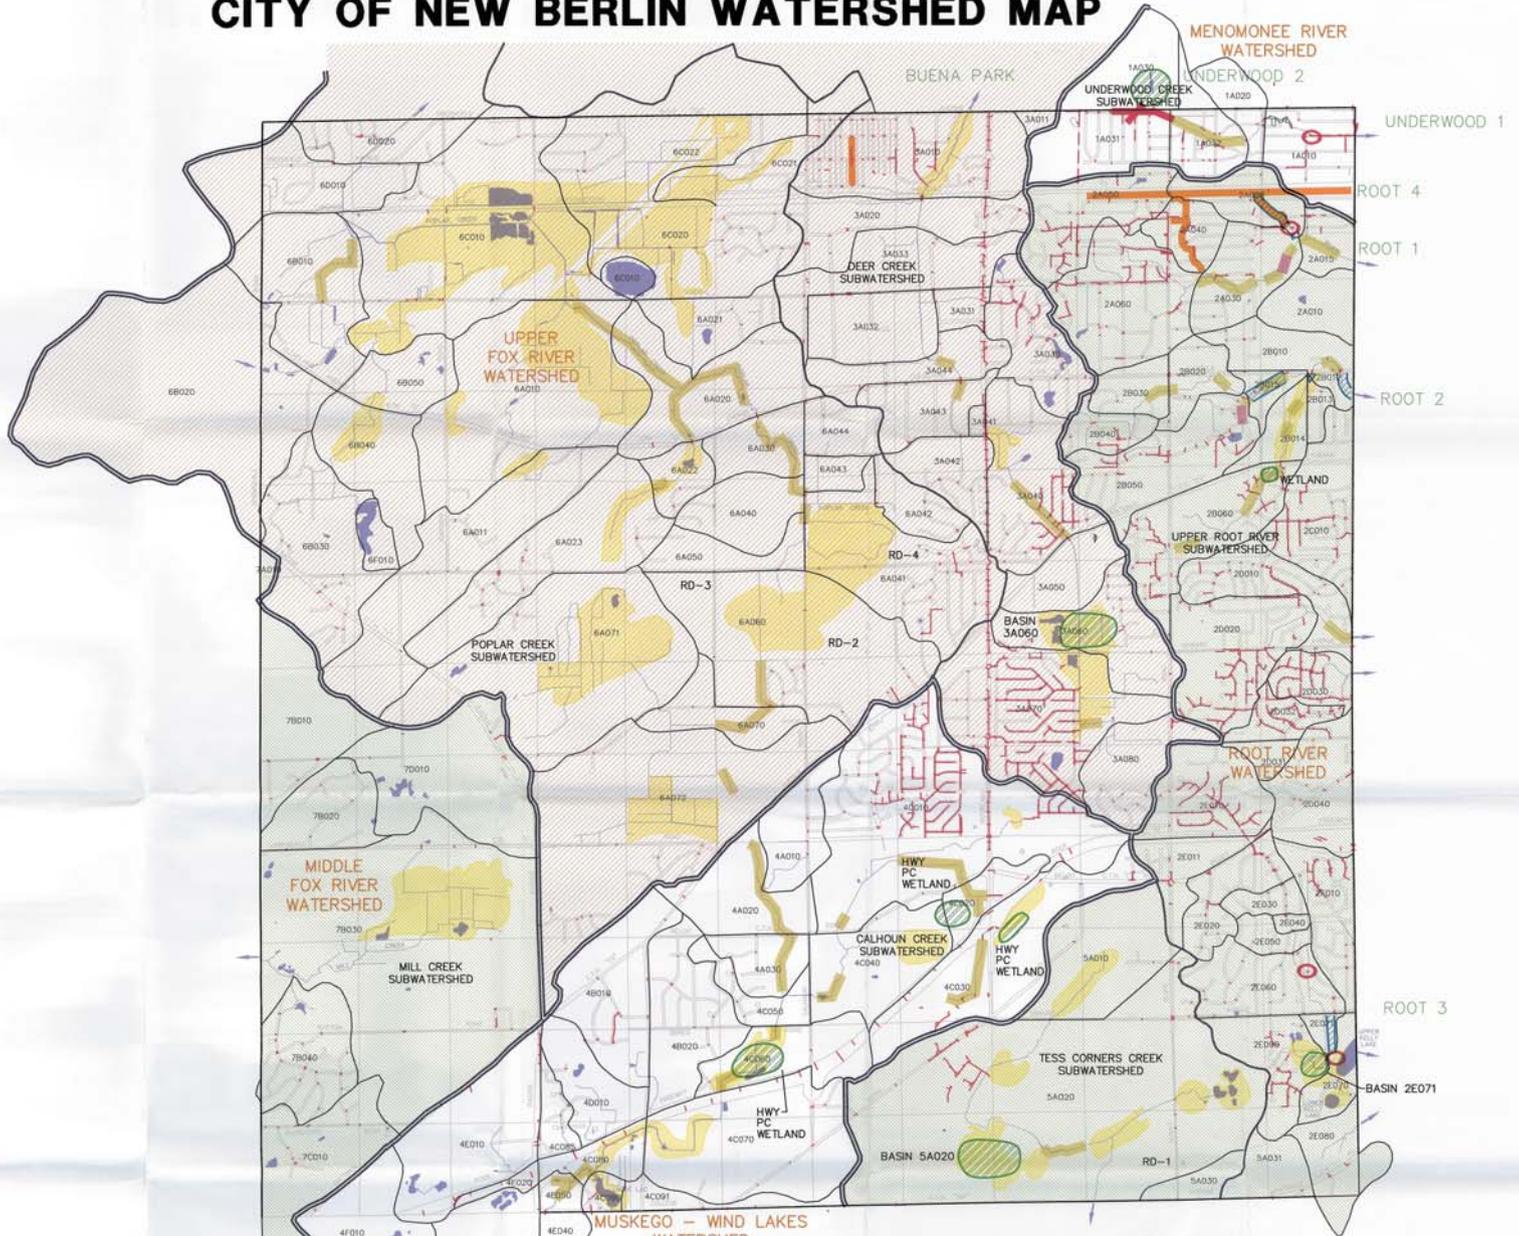
## EXISTING WETLAND AREAS Figure 4-7

The inventory identified 82 wetland areas within the study area incorporating 2,800 acres, or 12 percent of the total study area. The inventoried wetlands are shown on Figure 4-7. Over half (57%) of the total wetland areas are designated as prior converted. The prior converted wetland areas incorporate 1,570 acres. All of the wetland areas identified have been disturbed by development activities. Wetland areas within each subwatershed are summarized on Table 4-3.
